# Steering Intermediate Shaft Noise

YEAR(S)	MODEL(S)	ADDITIONAL INFORMATION
2006 – 2008	RAV4

### TSB SUPERSESSION NOTICE

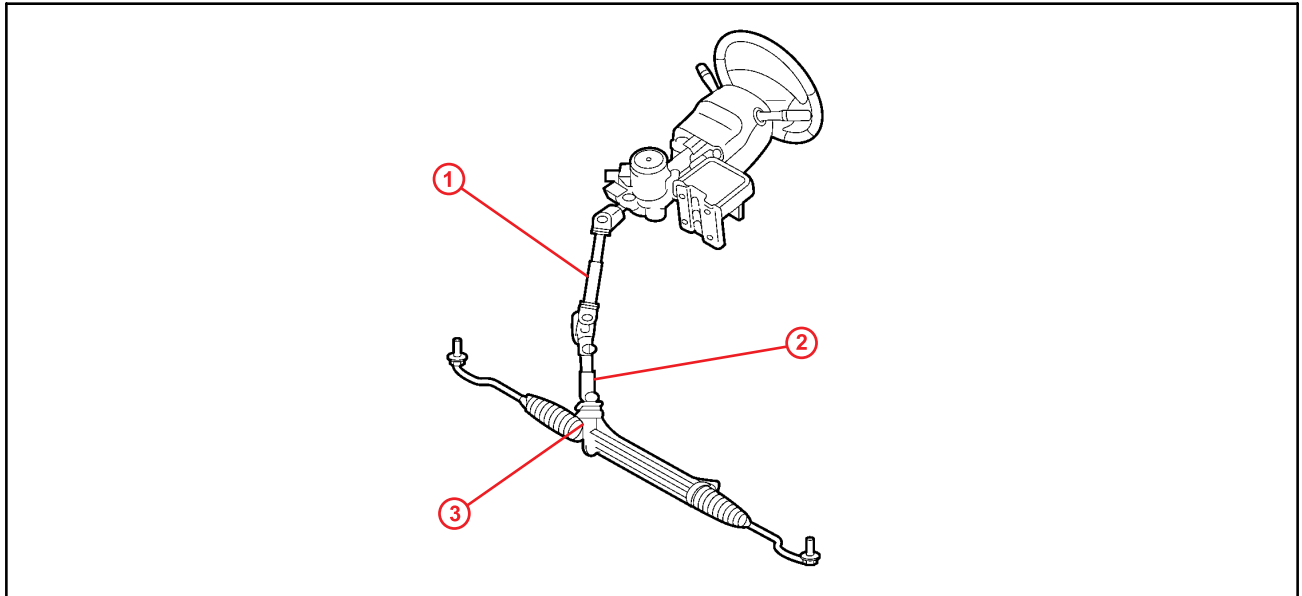
**Figure 1.**

Some customers may hear a clunk, pop, or knock-type noise when turning the steering wheel left or right. A new intermediate shaft has been developed to address this condition. Use the following repair procedure to remove and replace both steering intermediate shafts (No. 1 and No. 2).
