Hybrid Warning Message DTC P1CCC96 - Poor Ground Connection DC/DC Converter

Service Category Engine/Hybrid System

Section Hybrid/Battery Control System

YEAR(S)	MODEL(S)	ADDITIONAL INFORMATION
2021	RAV4 Prime	VDS(s): AB3FV, CB3FV, EB3FV, FB3FV, GB3FV

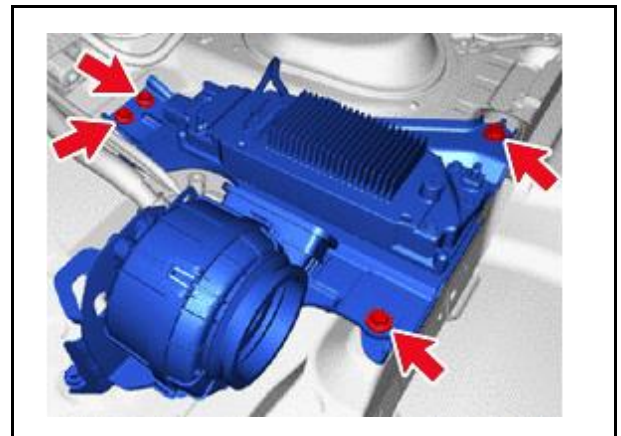
Figure 1.

Some 2021 model year RAV4 Prime vehicles may exhibit a MIL ON condition with Diagnostic Trouble Code (DTC) P1CCC96 (DC/DC Converter Enable Component Internal Failure). This condition may occur from a plating issue with the DC/DC mounting bolts that cause high resistance. Follow the Repair Procedure in this bulletin to address this condition.

- B. Remove the four ground bolts and replace with the NEW updated bolts.
